Polywater® UPR™

Wood-Pole Repair at Duke Energy® Lineman's Rodeo

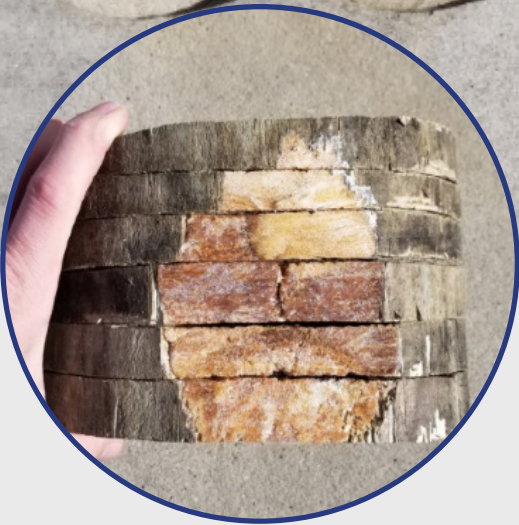
Duke Energy® line workers from around the state compete in hurt-man rescues, equipment repair, and pole-climb competitions during the annual rodeo. They are judged on speed, agility, technique, and safety procedures. A week prior to the 2020 Duke Energy Lineman's Rodeo in Florida, the pole yard was constructed. Two days after setting the poles, the staff identified two poles which already had woodpecker damage. The first pole had a 1-inch-deep hole and the other pole was significantly hollowed out.

In order to avoid the time and expense of replacing a pole, the rodeo organizers planned to repair the pole and leave it up for the event. They determined Polywater® UPR™ would be the right product for this situation. UPR is a two-part foam that mixes in the nozzle when applied. Since epoxies' interaction temperature can reach up to 300°, a no-touch application is the safest method. UPR's unique formula expands to fully fill the void, even above the entrance. No additional drilling is required which is safer and saves time. It was determined that the hollowed-out pole was compromised and was replaced, but UPR was applied to determine its effectiveness on significant woodpecker damage.

The smaller hole, once repaired, remained up for the rodeo event. The pole was inspected and determined to be gaff-able and load bearing—both qualities needed for the upcoming competition. Cross sections of the repaired, hollowed-out pole, shown above, were examined. It was determined that UPR had bonded to the wood. This prevents moisture and future degradation of a pole. Also, UPR fully sealed the hole, from the bottom to the top, due to its 3x expansion. Polywater UPR is a safe and effective solution for minor or extensive wood pole damage.

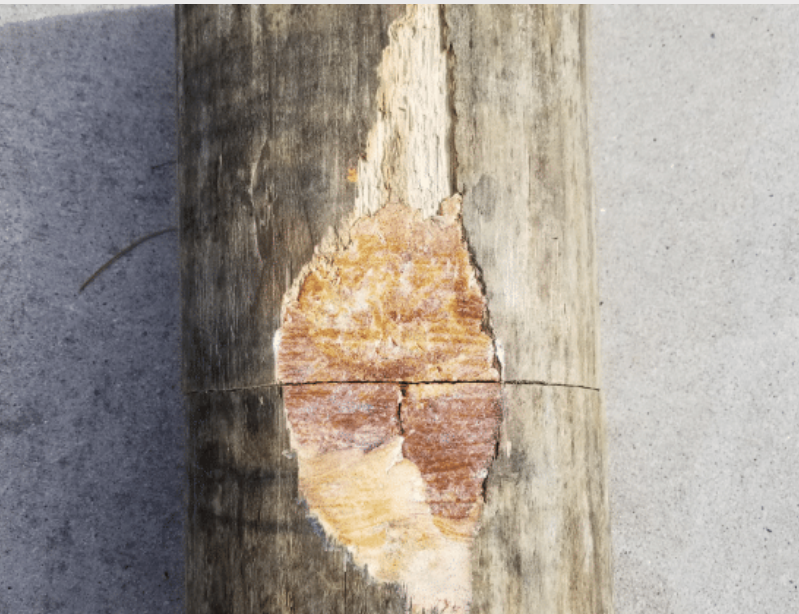
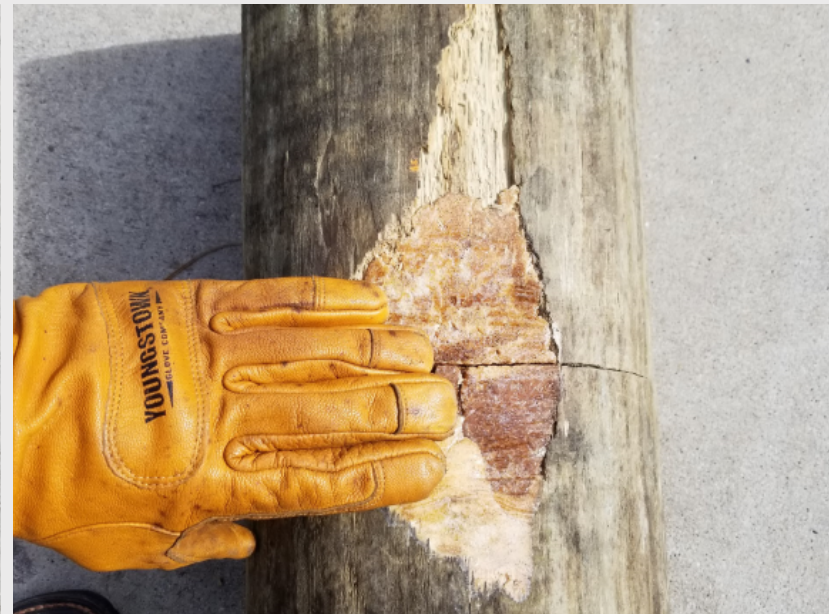
In the two pictures above you can see what the pole would've looked like after the field repair was made and before it was cut open.

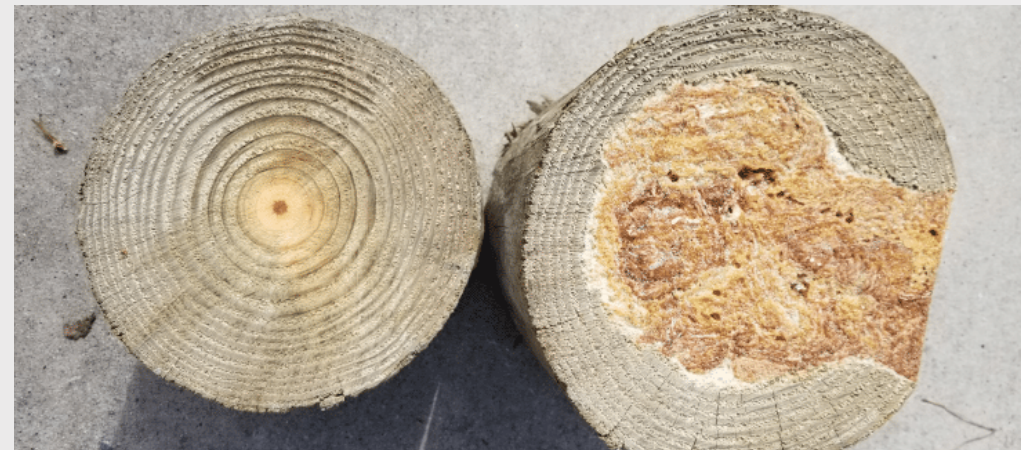
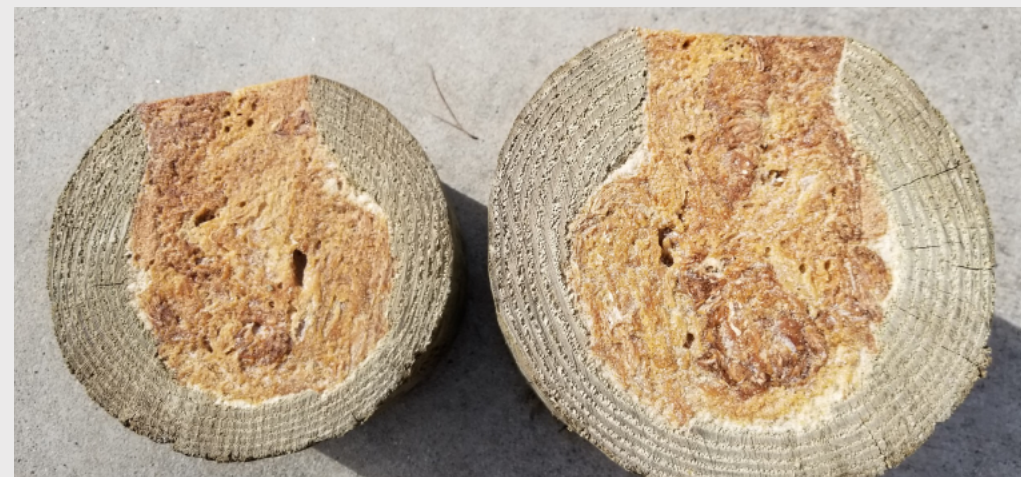
In these next two pictures to the left, you see a cross section of the pole where the repair was made. The first picture shows a good section of the pole beside a repaired section. The second picture shows both cross sections of the repair, top and bottom.

Polywater UPR expanded into the walls of the cavity created by the woodpecker and successfully filled the void.
