Polywater® UPR™

Wood-Pole Repair at Duke Energy® Lineman's Rodeo

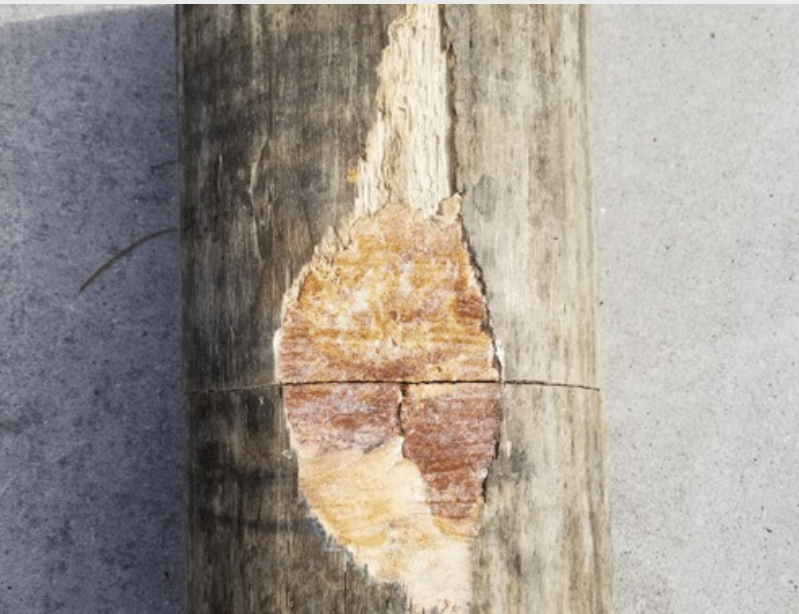
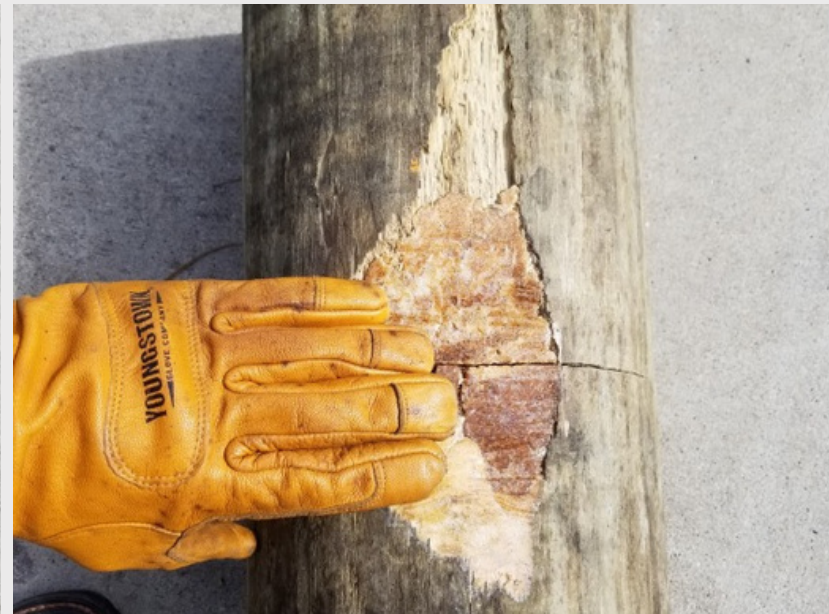
In the two pictures above you can see what the pole would've looked like after the field repair was made and before it was cut open.

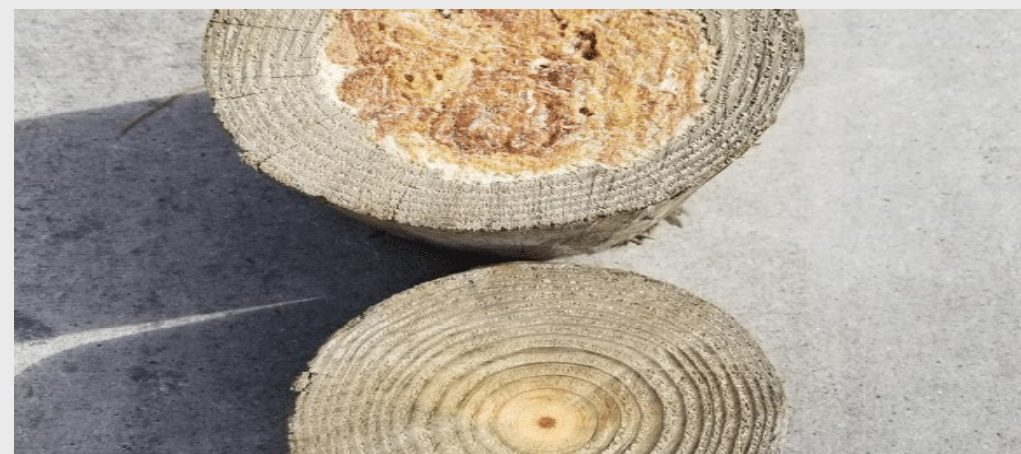
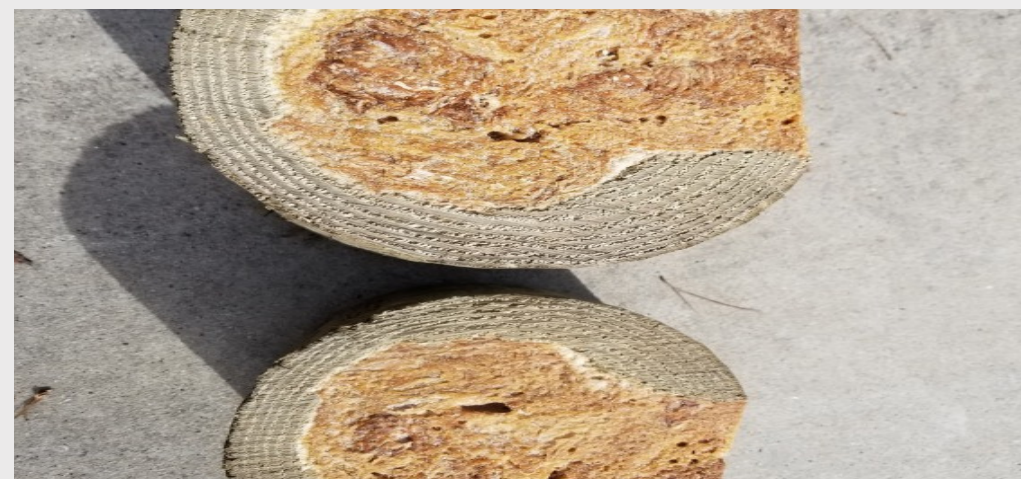
The smaller hole, once repaired, remained up for the rodeo event. The pole was inspected and determined to be gaff-able and load bearing—both qualities needed for the upcoming competition. Cross sections of the repaired, hollowed-out pole, shown above, were examined. It was determined that UPR had bonded to the wood. This prevents moisture and future degradation of a pole. Also, UPR fully sealed the hole, from the bottom to the top, due to its 3x expansion. Polywater UPR is a safe and effective solution for minor or extensive wood pole damage.

In these next two pictures to the left, you see a cross section of the pole where the repair was made. The first picture shows a good section of the pole beside a repaired section. The second picture shows both cross sections of the repair, top and bottom.

Polywater UPR expanded into the walls of the cavity created by the woodpecker and successfully filled the void.
