Polywater® UPR™

Wood-Pole Repair at Duke Energy® Lineman's Rodeo

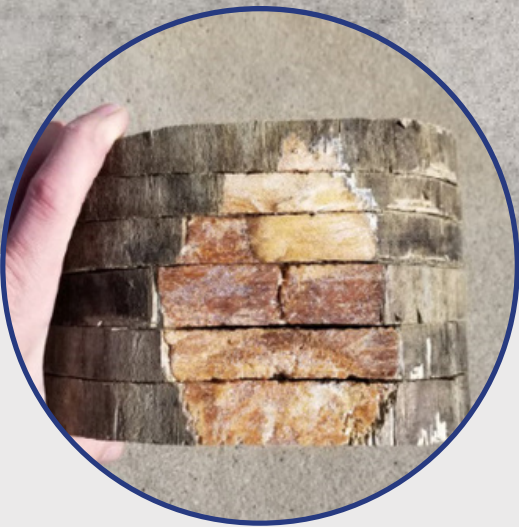
Duke Energy® line workers from around the state compete in hurt-man rescues, equipment repair, and pole-climb competitions during the annual rodeo. They are judged on speed, agility, technique, and safety procedures. A week prior to the 2020 Duke Energy Lineman's Rodeo in Florida, the pole yard was constructed. Two days after setting the poles, the staff identified two poles which already had woodpecker damage. The first pole had a 1-inch-deep hole and the other pole was significantly hollowed out.

In order to avoid the time and expense of replacing a pole, the rodeo organizers planned to repair the pole and leave it up for the event. They determined Polywater® UPR™ would be the right product for this situation. UPR is a two-part foam that mixes in the nozzle when applied. Since epoxies' interaction temperature can reach up to 300°, a no-touch application is the safest method. UPR's unique formula expands to fully fill the void, even above the entrance. No additional drilling is required which is safer and saves time. It was determined that the hollowed-out pole was compromised and was replaced, but UPR was applied to determine its effectiveness on significant woodpecker damage.

The smaller hole, once repaired, remained up for the rodeo event. The pole was inspected and determined to be gaff-able and load bearing—both qualities needed for the upcoming competition. Cross sections of the repaired, hollowed-out pole, shown above, were examined. It was determined that UPR had bonded to the wood. This prevents moisture and future degradation of a pole. Also, UPR fully sealed the hole, from the bottom to the top, due to its 3x expansion. Polywater UPR is a safe and effective solution for minor or extensive wood pole damage.
